Mt. Royal Tributary Restoration Monitoring Report

Prepared for:
The Harford County
Department of Public
Works

January 2005

Prepared by:
KCI Technologies Inc.
10 North Park Drive
Hunt Valley, MD
21030

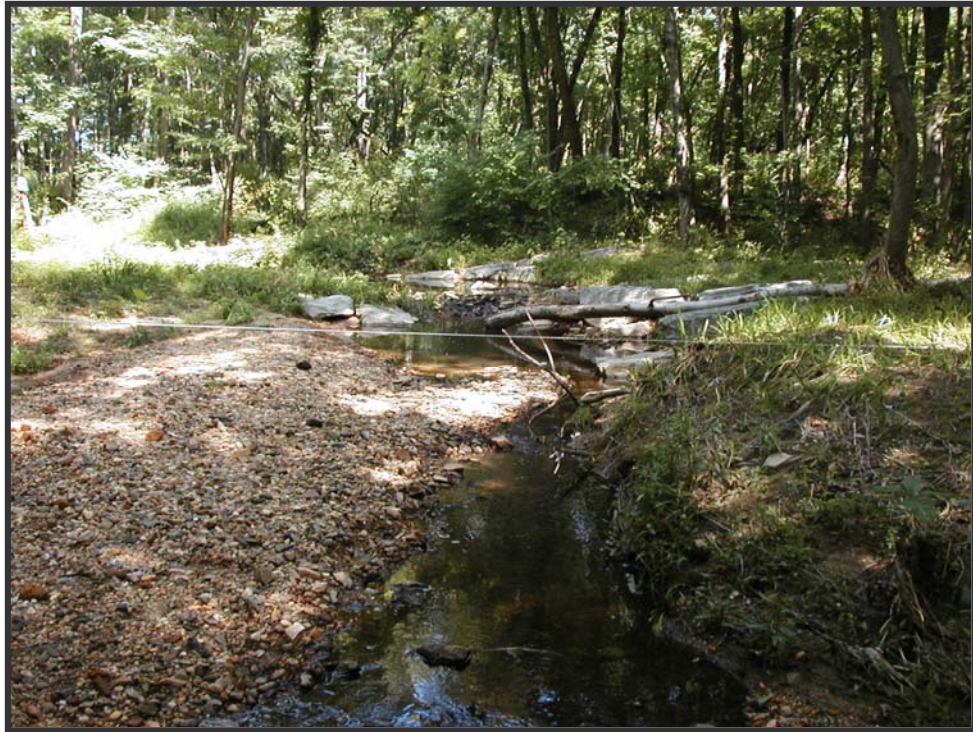
Photo ID 1 – Station 0+45, facing upstream, July 2004

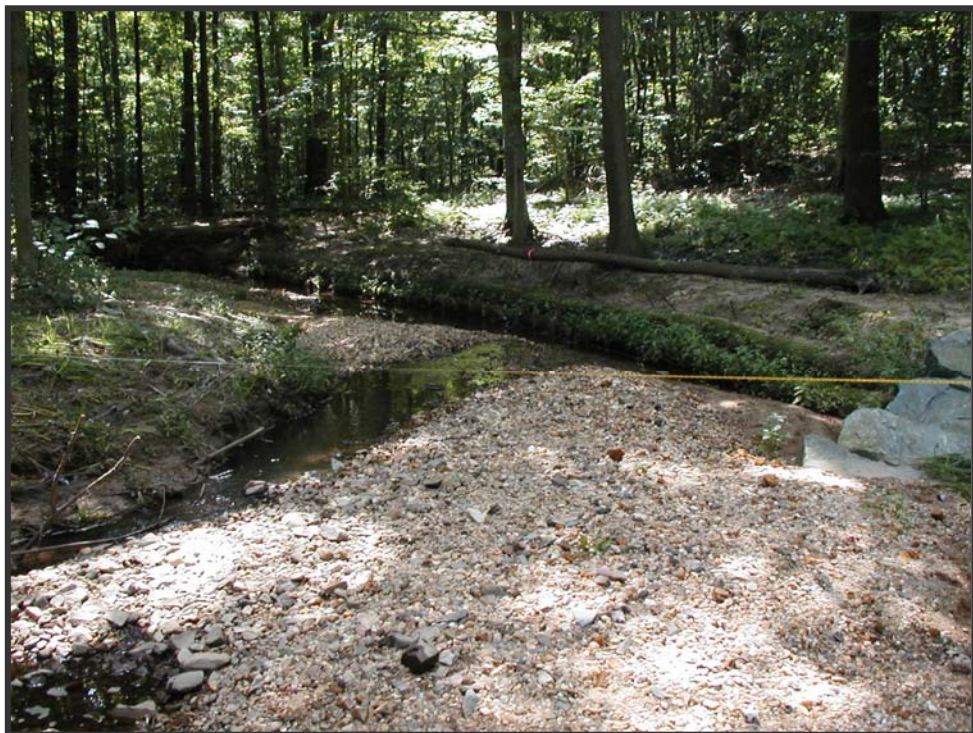
Photo ID 2 – Station 0+45, facing downstream, July 2004

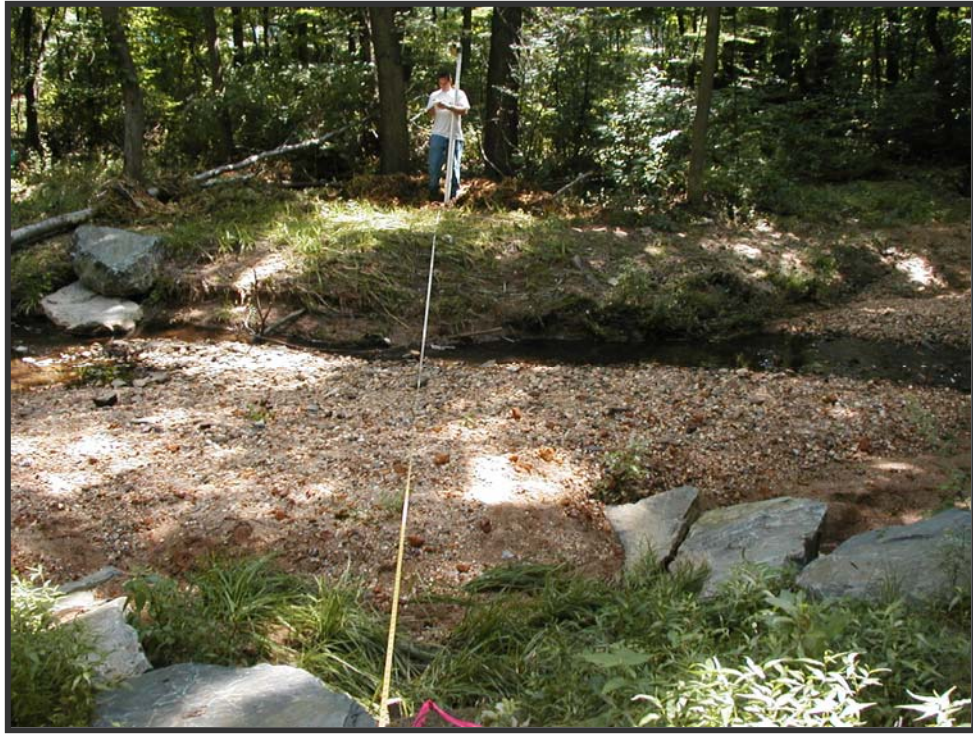
Photo ID 3 – Station 0+45, right bank, July 2004

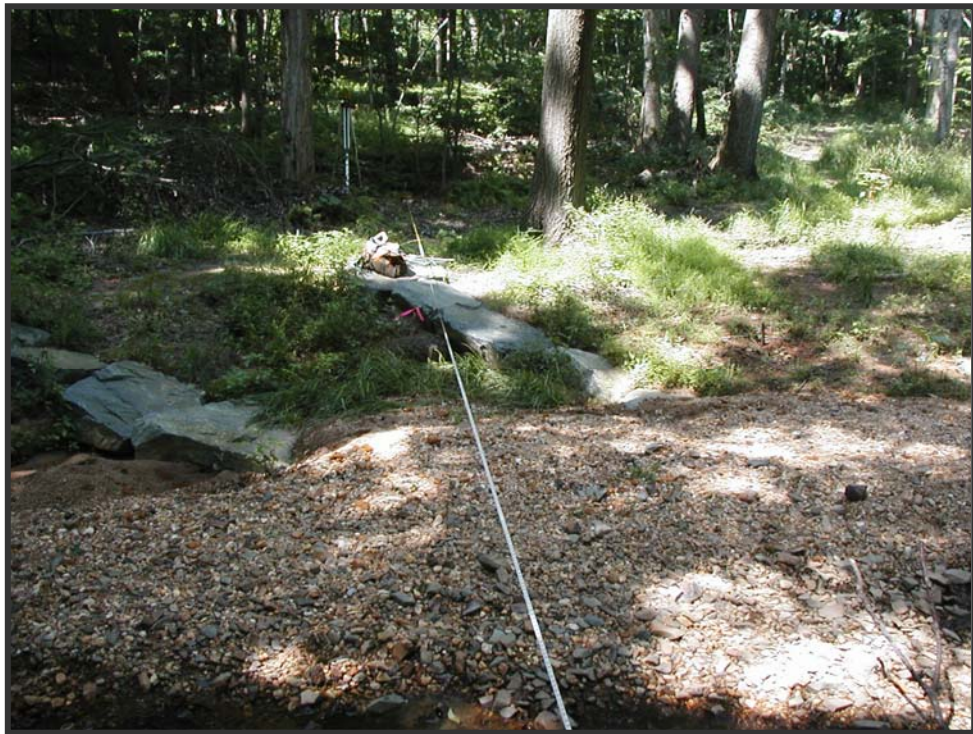
Photo ID 4 – Station 0+45, left bank, July 2004

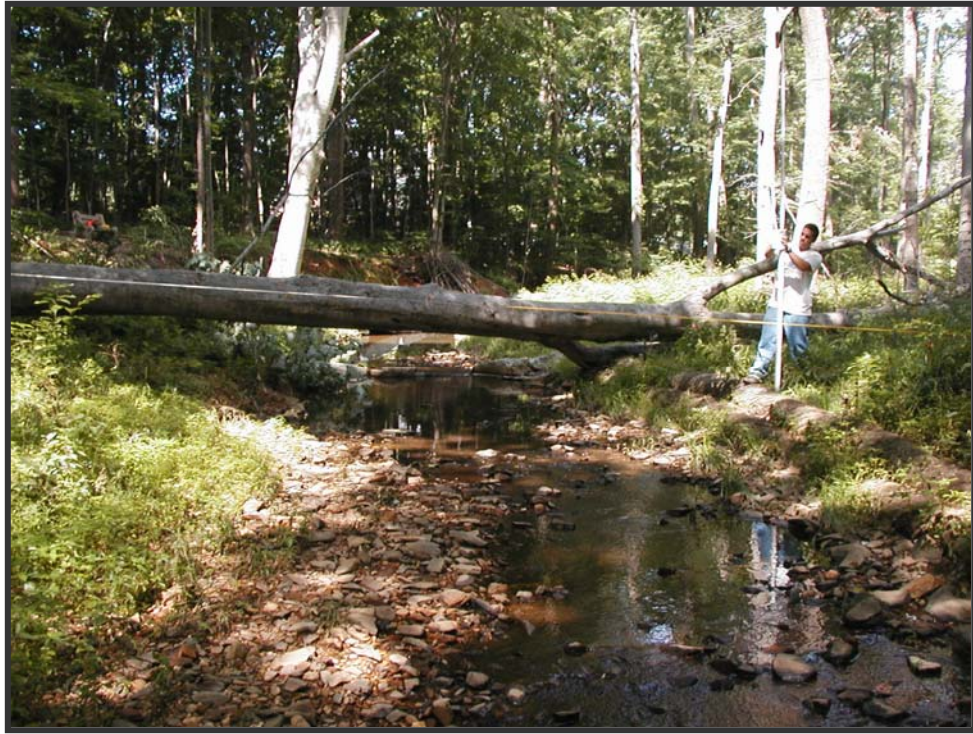
A downed American beech tree is located near station 3+45, immediately upstream from one of the monumented cross-sections (Section 2), but the tree does not appear to inhibit baseflow. At the present time, it appears that no erosion is occurring during higher flows around or near the tree. An area of concern that should be monitored includes the left bank between stations 4+00 and 5+00 in the area labeled as a remnant oxbow (see Appendix A, Photo 12). Vegetation is sparse in this area and roots are exposed. Subsequent annual monitoring will be performed to track potential problems in these areas. The cross-section located at Station 4+45 will provide significant monitoring data to substantiate any changes that occur to the bank.

Photo ID 5 – Station 3+35, facing upstream, July 2004
Note: American Beech down across channel

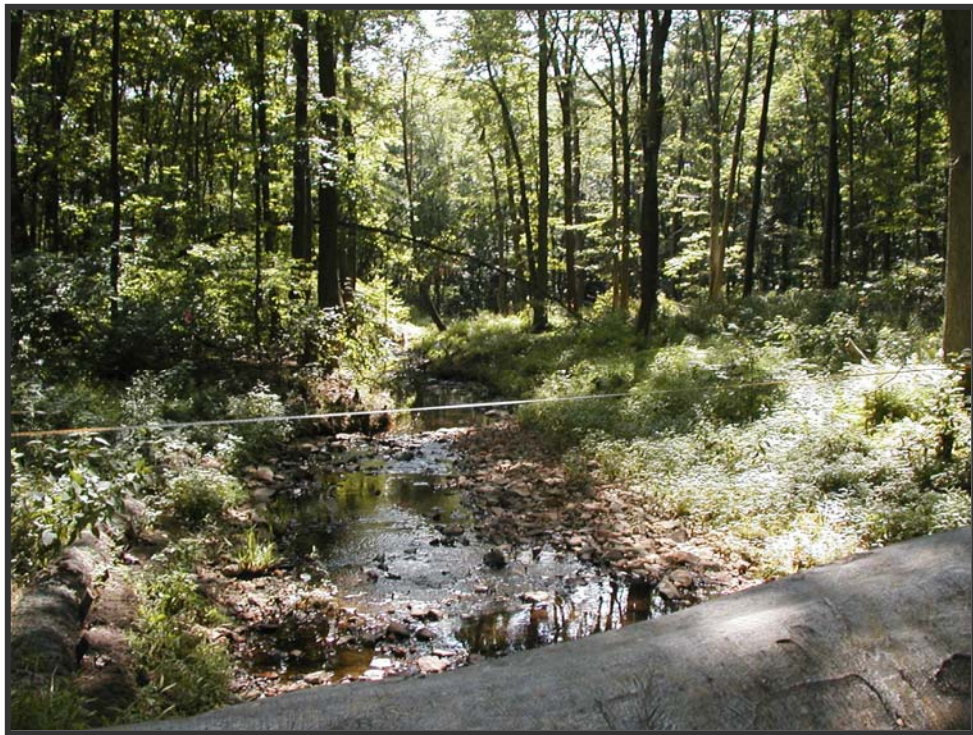
Photo ID 6 – Station 3+35, facing downstream, July 2004

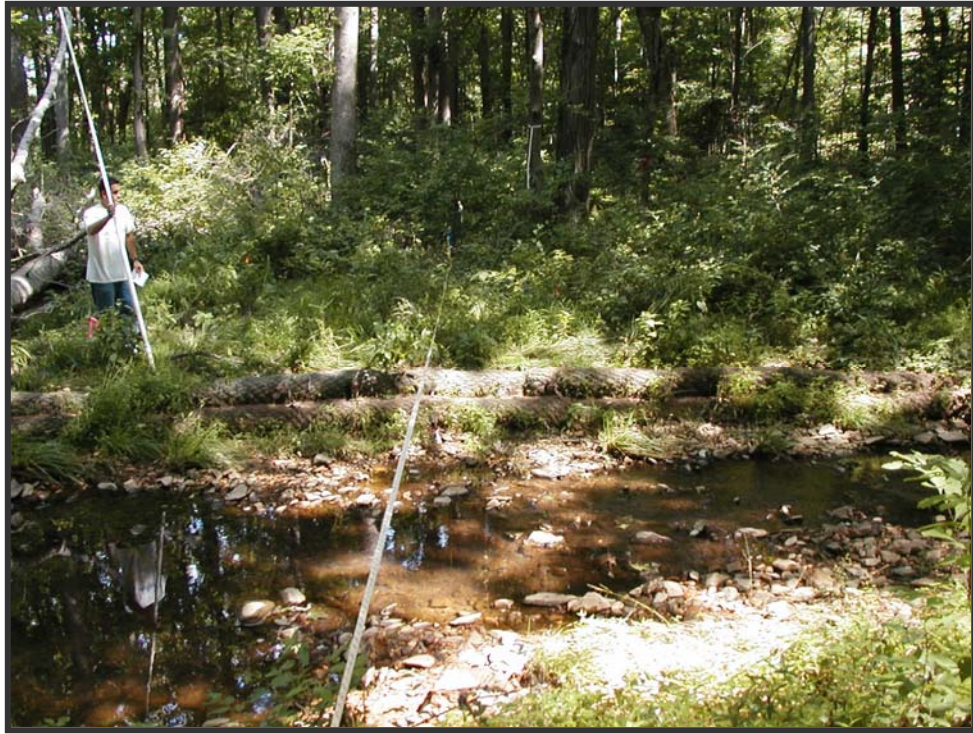
Photo ID 7 – Station 3+35, right bank, July 2004

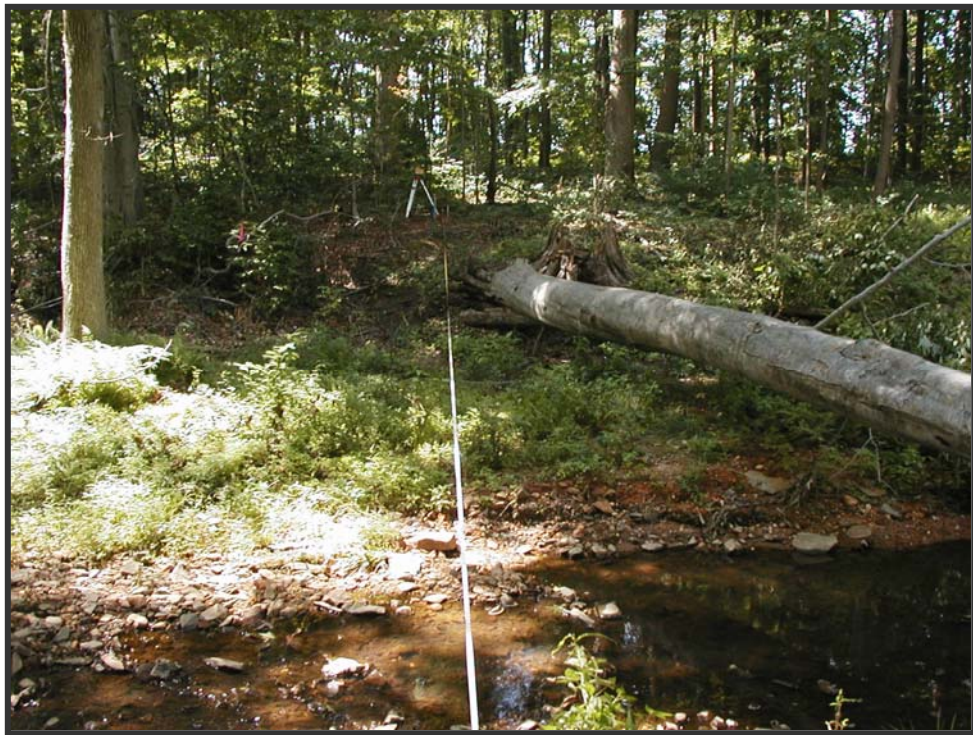
Photo ID 8 – Station 3+35, left bank, July 2004

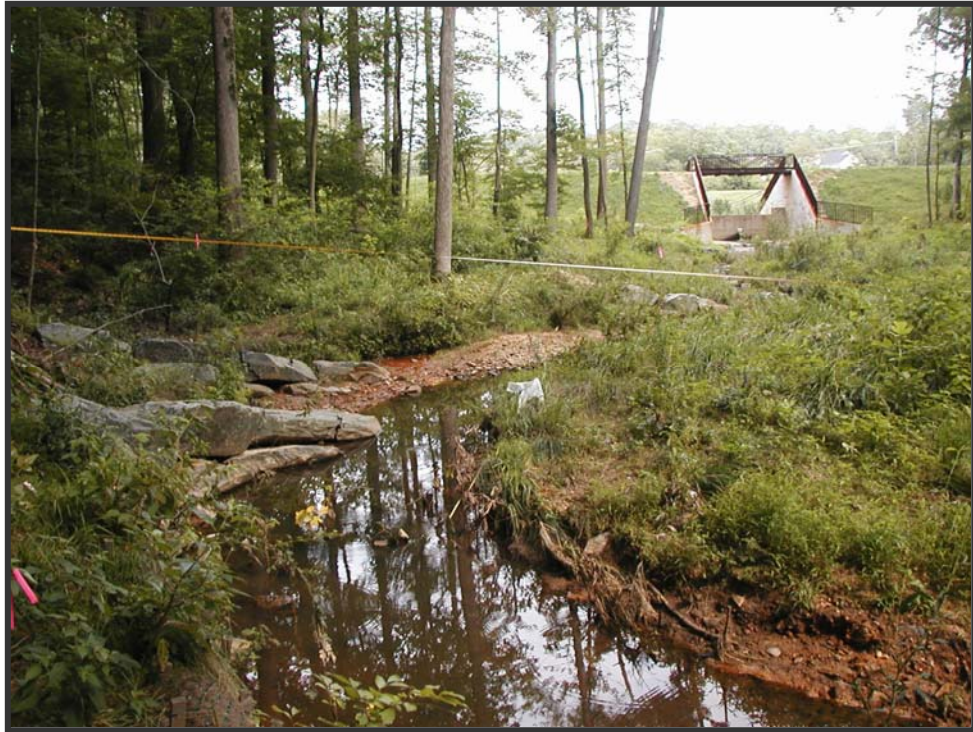
Photo ID 9 – Station 4+45, facing upstream, July 2004

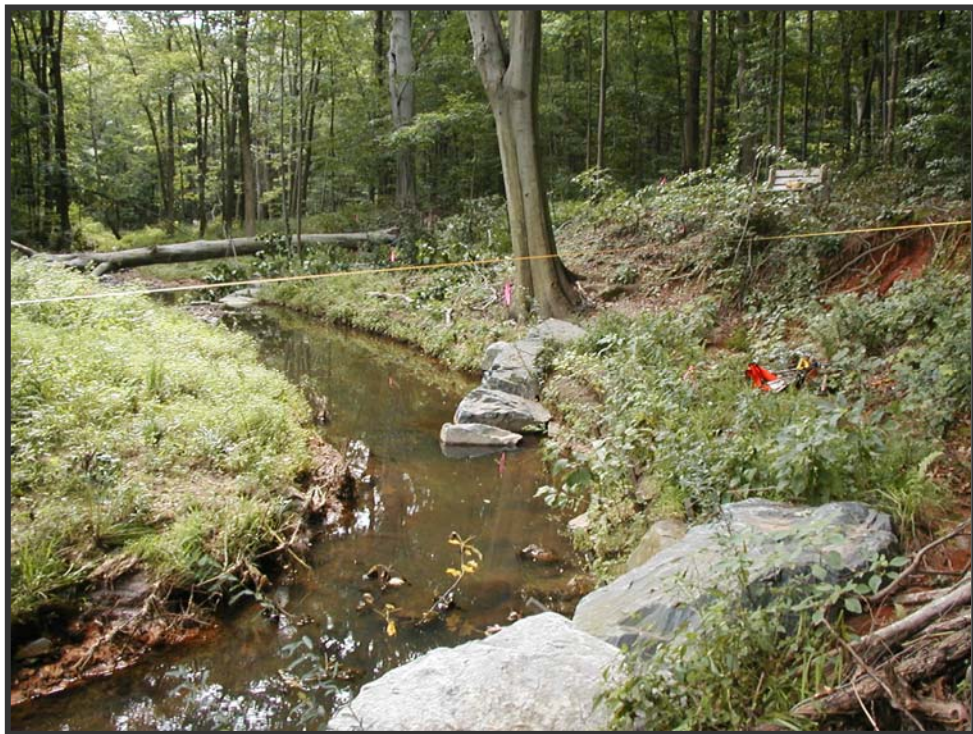
Photo ID 10 – Station 4+45, facing downstream, July 2004

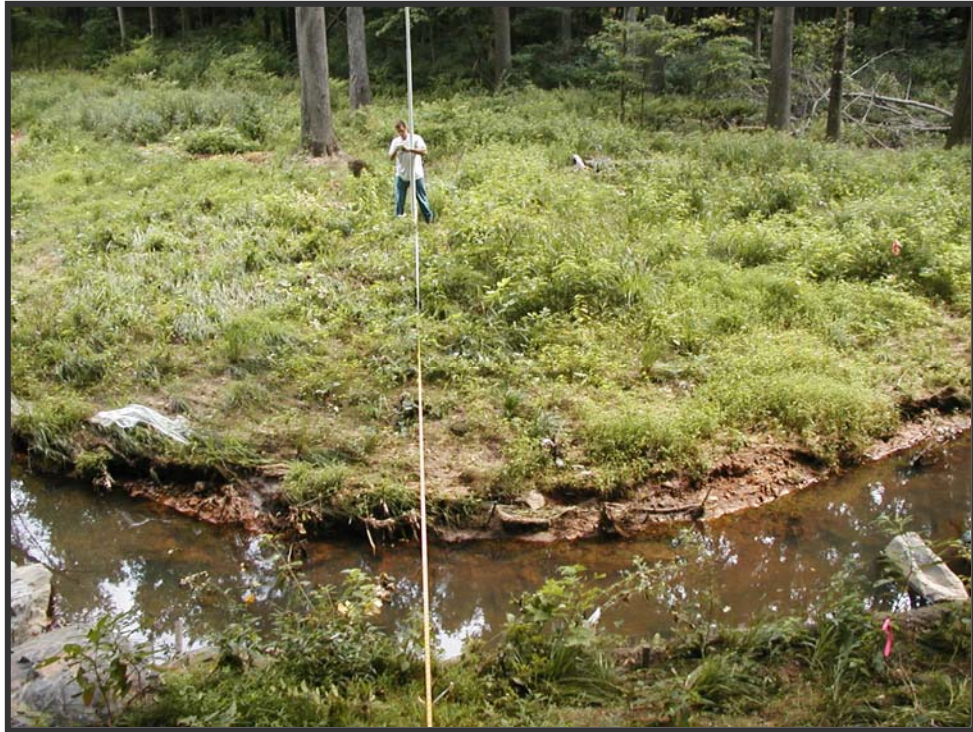
Photo ID 11 – Station 4+45, right bank, July 2004

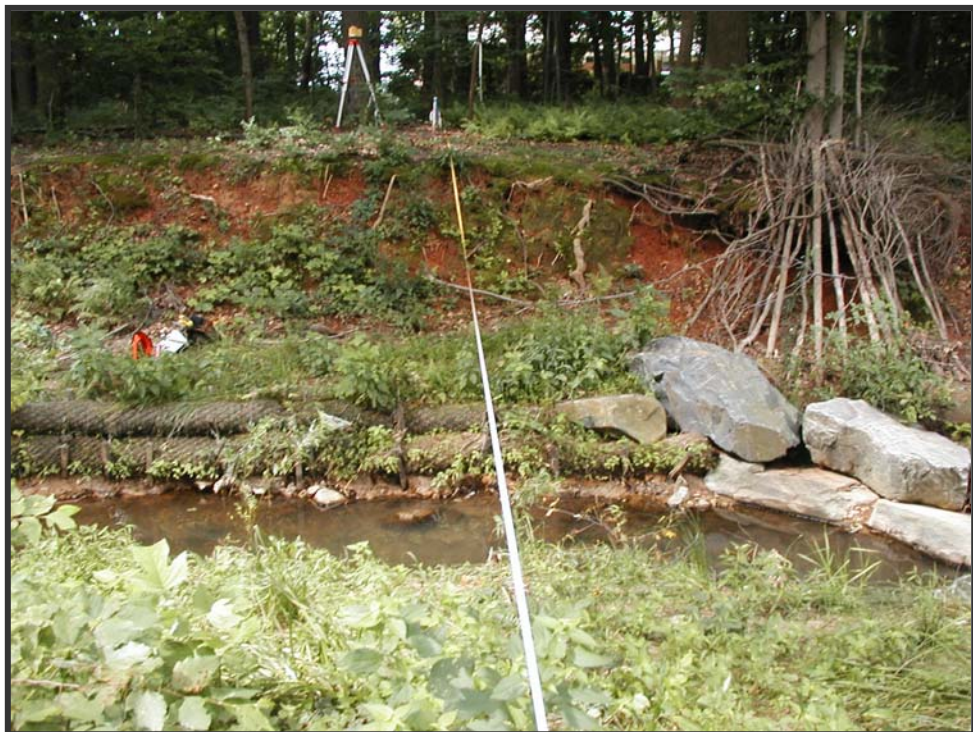
Photo ID 12 – Station 4+45, left bank, July 2004
Note: Exposed existing bank

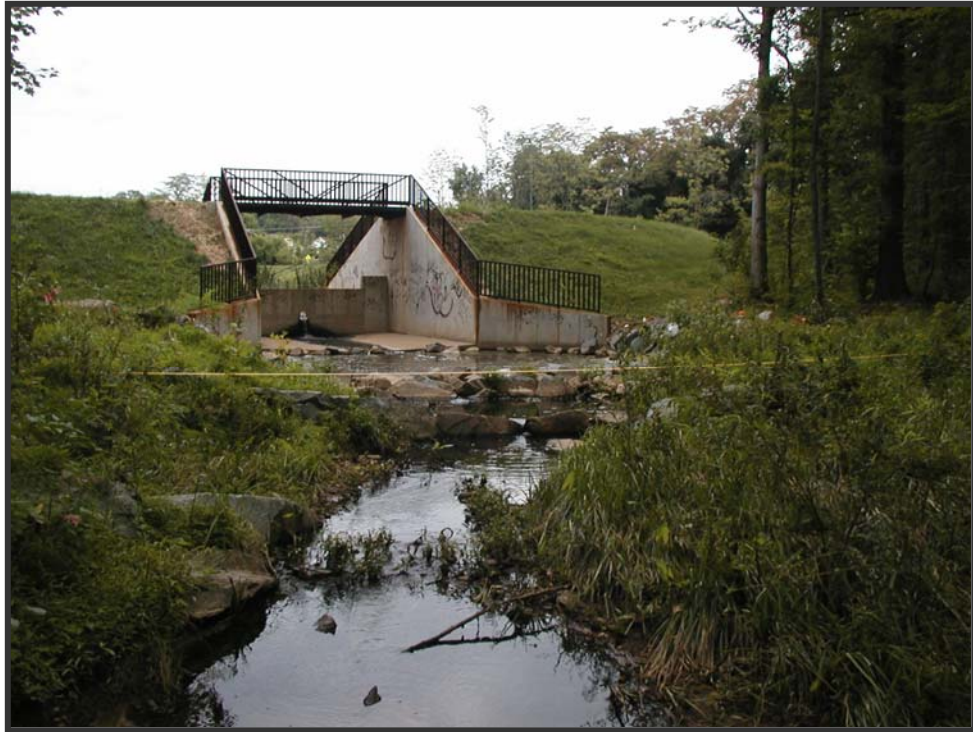
Photo ID 13 – Station 5+70, facing upstream, July 2004

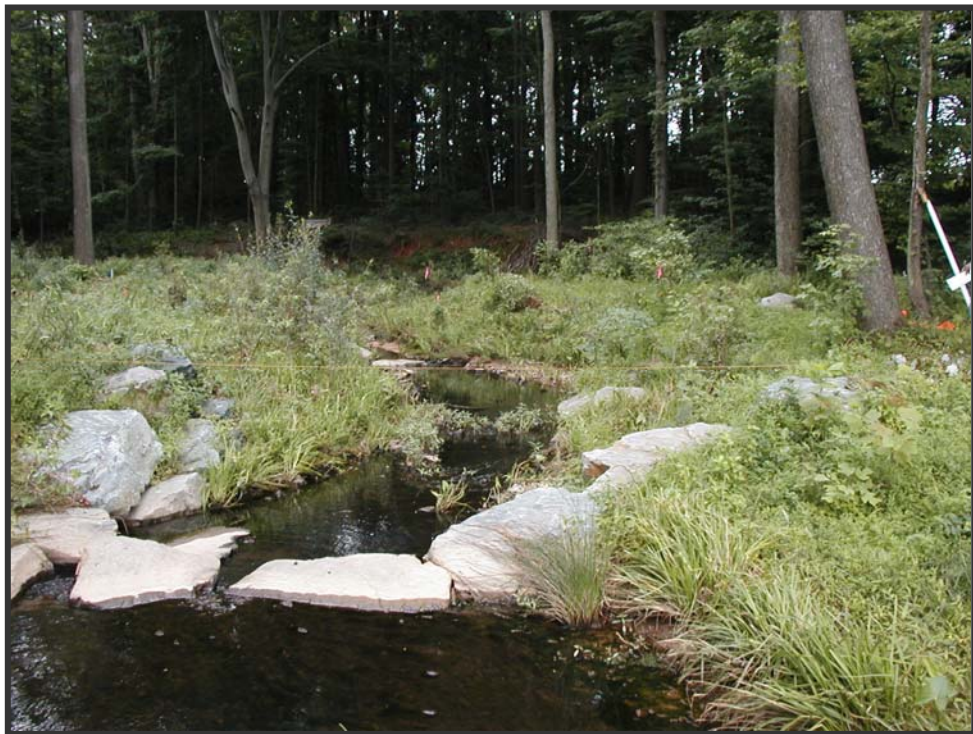
Photo ID 14 – Station 5+70, Facing downstream, July 2004

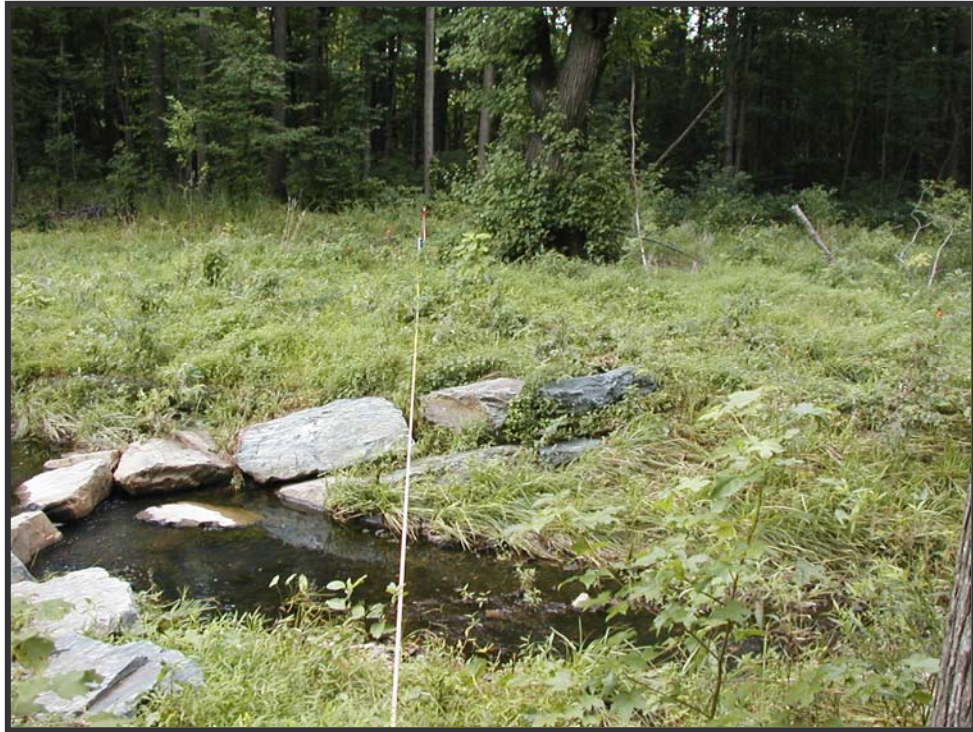
Photo ID 15 – Station 5+70, right bank, July 2004

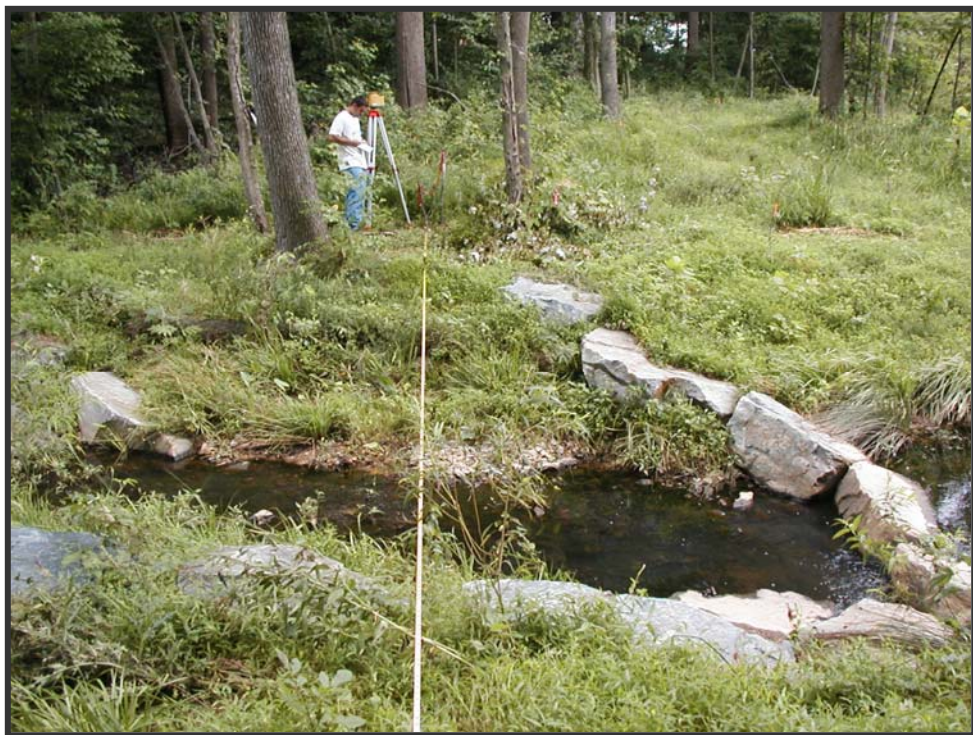
Photo ID 16 – Station 5+70, left bank, July 2004
